## Rain Bird® Two-Wire PAR+ES Controllers

Two-Wire PAR+ES Controllers install quickly, boast the best-in-class user interface pedestal enclosure and are durably constructed. The base configuration of 16 stations can be upgraded at any time — in eight-station increments up to 72 stations — to accommodate changing course irrigation requirements. In the central control mode, an unlimited number of irrigation schedules can be programmed to further enhance watering flexibility and precision. To safeguard the controller investment, a choice of pedestals in either green or grey are available to provide superior environmental protection.

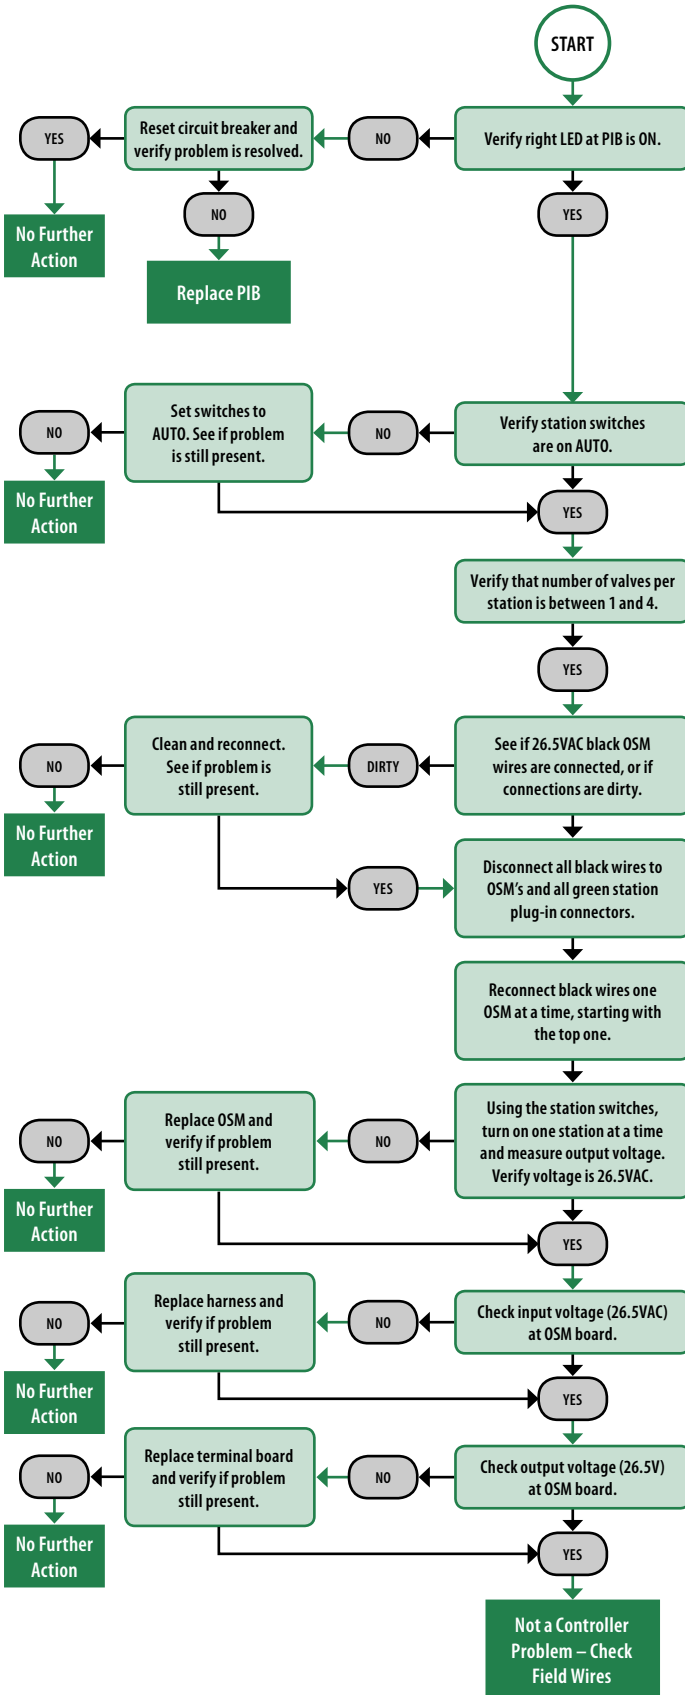
# “All/Some Stations Not Working”

Front panel indicates that stations  
are running but no irrigation

» Note: This  
troubleshooting card  
assumes that water  
and pressure are ok.

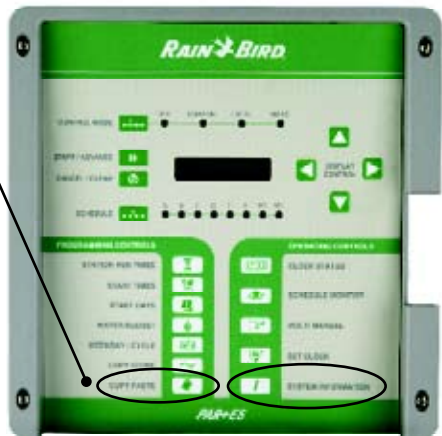
## How to perform a Factory Reset/Cold Boot with a non-responding key pad

1. Turn Power **OFF**
2. Hold **COPY PASTE** and **SYSTEM INFORMATION**
3. Turn Power **ON**
4. Hold button down until **NEW SYSTEM SETUP** appears in display

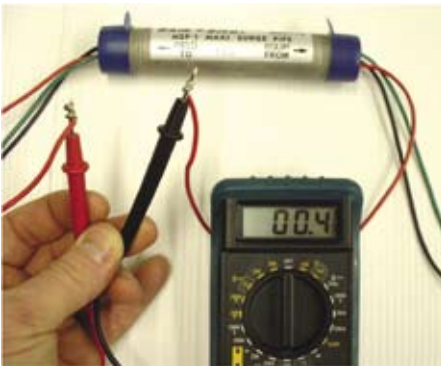
## Testing of MSP-1 Surge Arrestor

- All three wires are a continuous path through the LINE and EQUIP ends
- The green wire from both ends must be physically grounded together
- The MSP-1 surge arrester unit is directional and the end marked LINE must be connected to the two-wire path coming from the field.

Use digital multi-meter on its Ohm setting

- Check for continuity through red to red, black to black, and green to green. Reading should be  $\sim 0\Omega$ .
- There should NOT be continuity between any wire of mixed colors. Reading should be  $\sim 750\Omega$ .

The failure of any of the above tests indicates a malfunctioning surge arrester and will not provide any further protection and necessitates the replacement of the current MSP-1
